IDR Sheet	1	of	2	Sheets	Final Record Book	Page
Contract	C-7852			Day	Tuesday	
				Date	July 13, 2010

Inspector's Daily Report

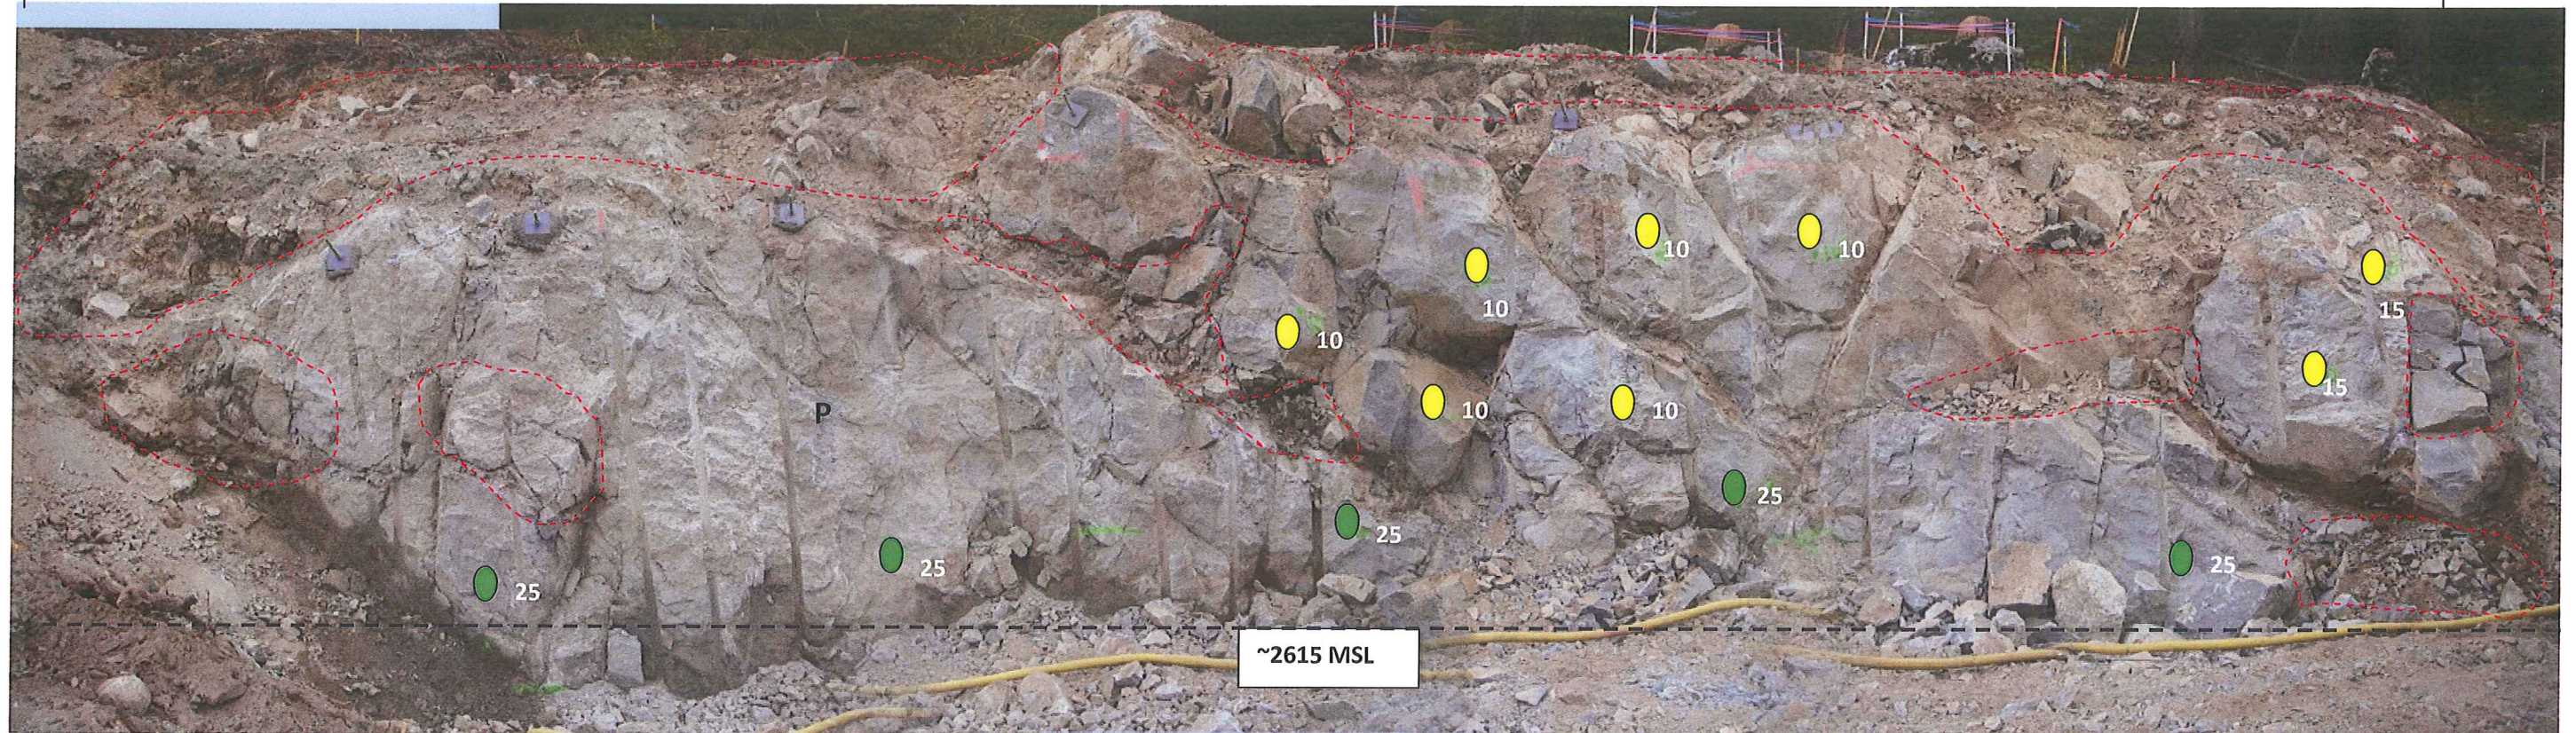
I arrived on site around 8:00 am and met with Brad Schut to lay out dowels for Lift 1 from approximate station LW 1336+50 to 1337+20 to approximate elevation 2615 mean sea level (MSL) (Figure 1). During our inspection of Lift 1, we observed a few detached blocks that were located on adversely oriented discontinuities (40 to 45 degrees) forming wedges. The discontinuities forming these wedges were infilled with material consisting of silty sand with gravels and cobbles. These wedge forming blocks will require stabilization. Brad and I field located these spot dowels for these detached blocks. The location of these Type L spot dowels can be seen in Figure 1. The Type L pattern dowels located at the bottom of the lift (per the contract plans), and a monitoring prism within the exposed face were also field located (See Figure 1). Brad and I also observed loose material that remained on the slope that needed additional scaling and dressing (Figure 1), as provided for in the Standard Specifications 2010: Section 2-03 ROADWAY EXCAVATION AND EMBANKMENT, Subsection 2-03.3(2) Rock Cuts, Item 2. Scaling and Dressing: To leave rock cuts in a safe, stable condition, the Contractor shall scale and dress them, removing all loose fragments and rocks not firmly fastened to the rock slope. The Contractor shall also remove any overhanging rock the Engineer as a hazard to Roadway users.

Figure 1. Lift 1 from approximate station LW 1336+50 to 1337+20.

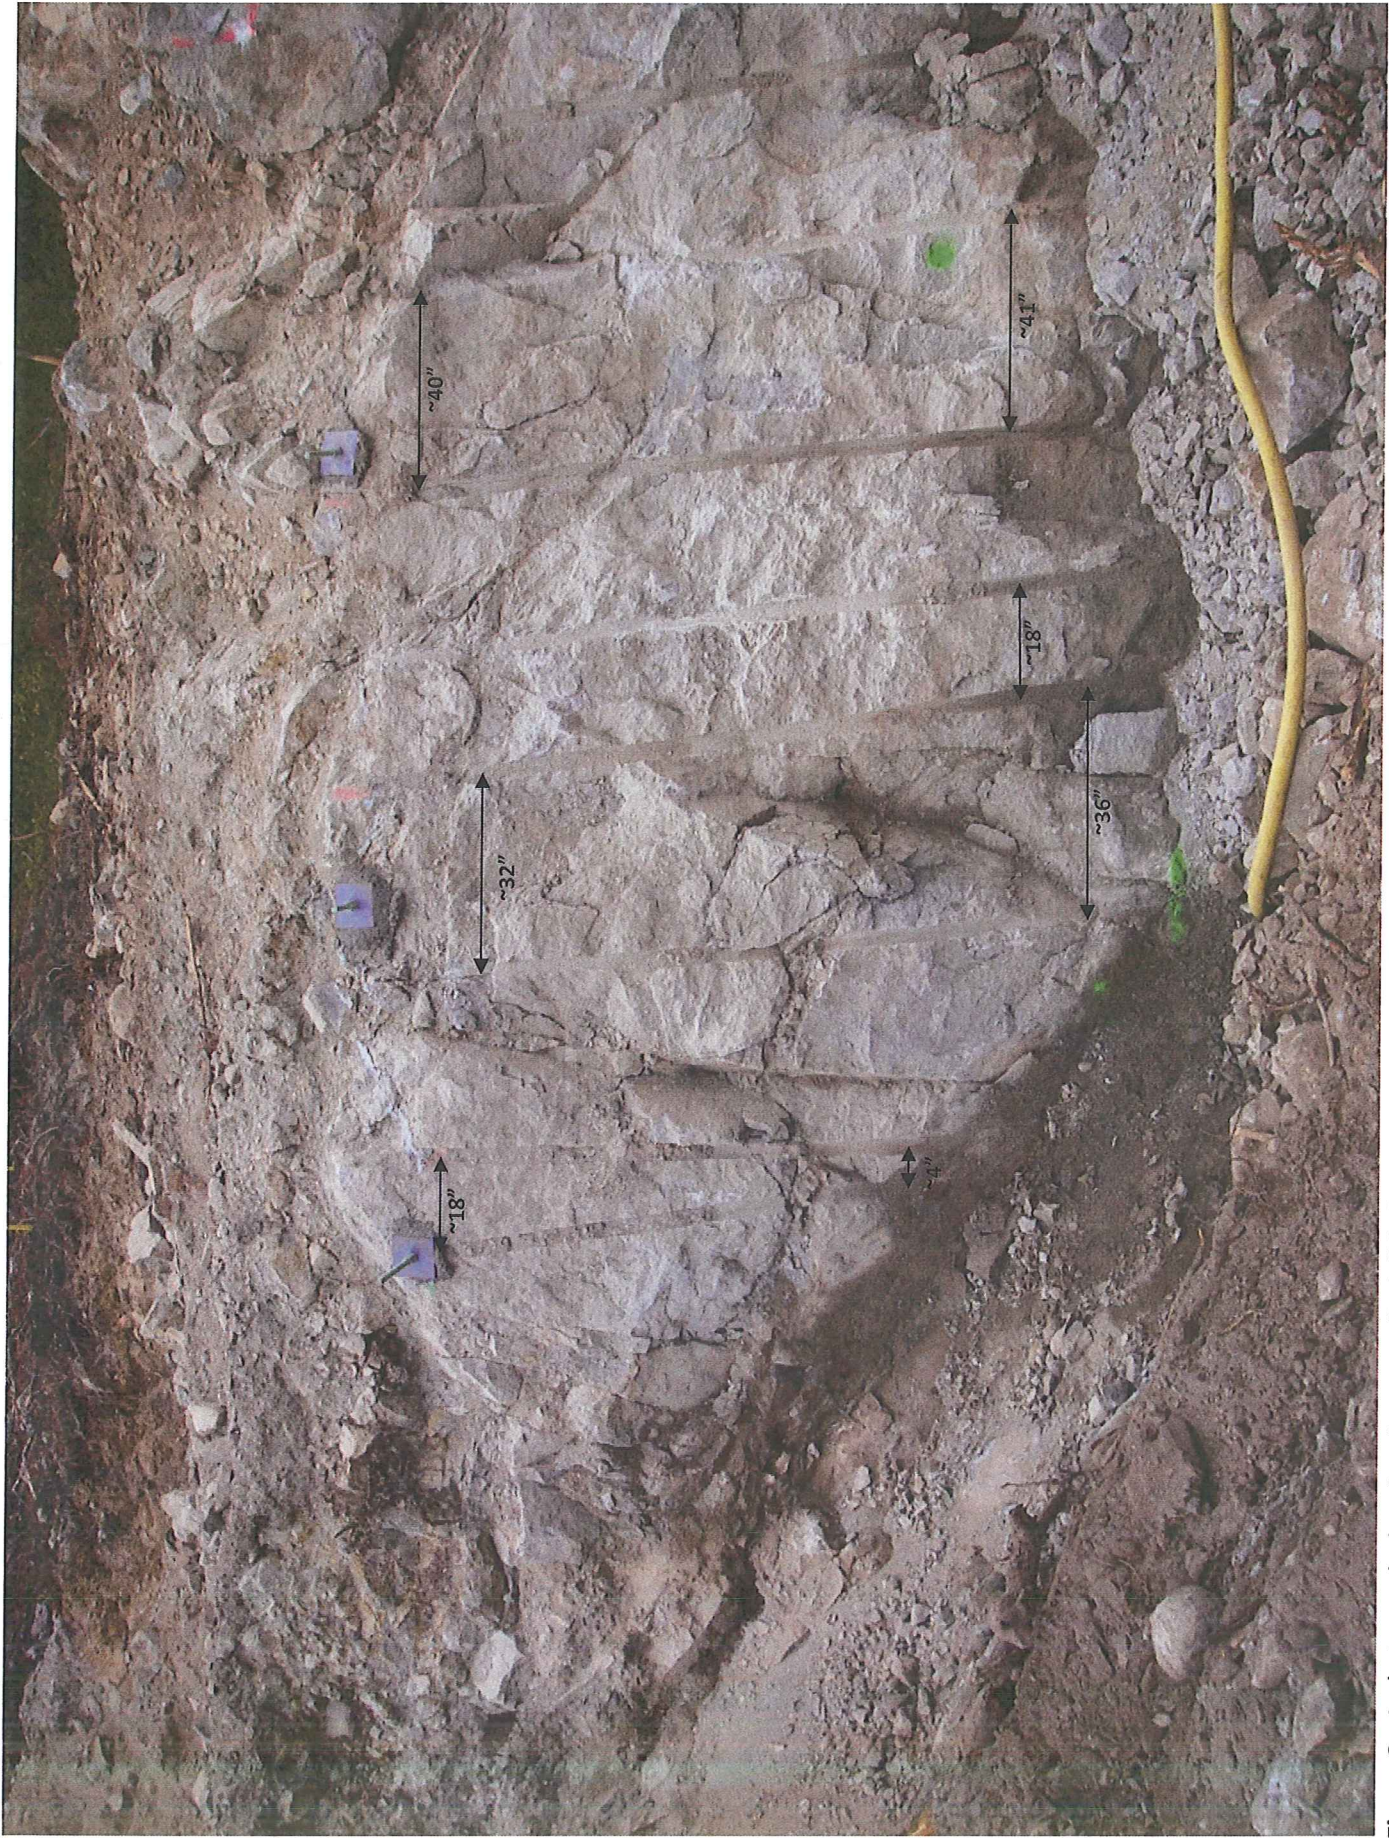
Following our dowel layout, Brad and I inspected the pre-split holes exposed in the cut face. We noted that numerous holes were not drilled at the proper spacing (30 inch centers) and have also exceeded our drift tolerances (no more than 9 inches of deviation either parallel or normal to the slope) per the Standard Specification (Section 2-03.3 (2) Controlled Blasting Item D. We measured the spacing of the pre-split holes towards the top of the lift and they ranged from 18 inches to 35 to 40 inches in places. We also measured the pre-split holes at the bottom of the lift to measure drift and the spacing ranged from a few inches to greater to 40 inches in places (Figure 2).

Figure 2. A photograph showing the pre-split drill holes at approximate station LW 1336+50. Note the inaccuracies in holes spacing and drift.

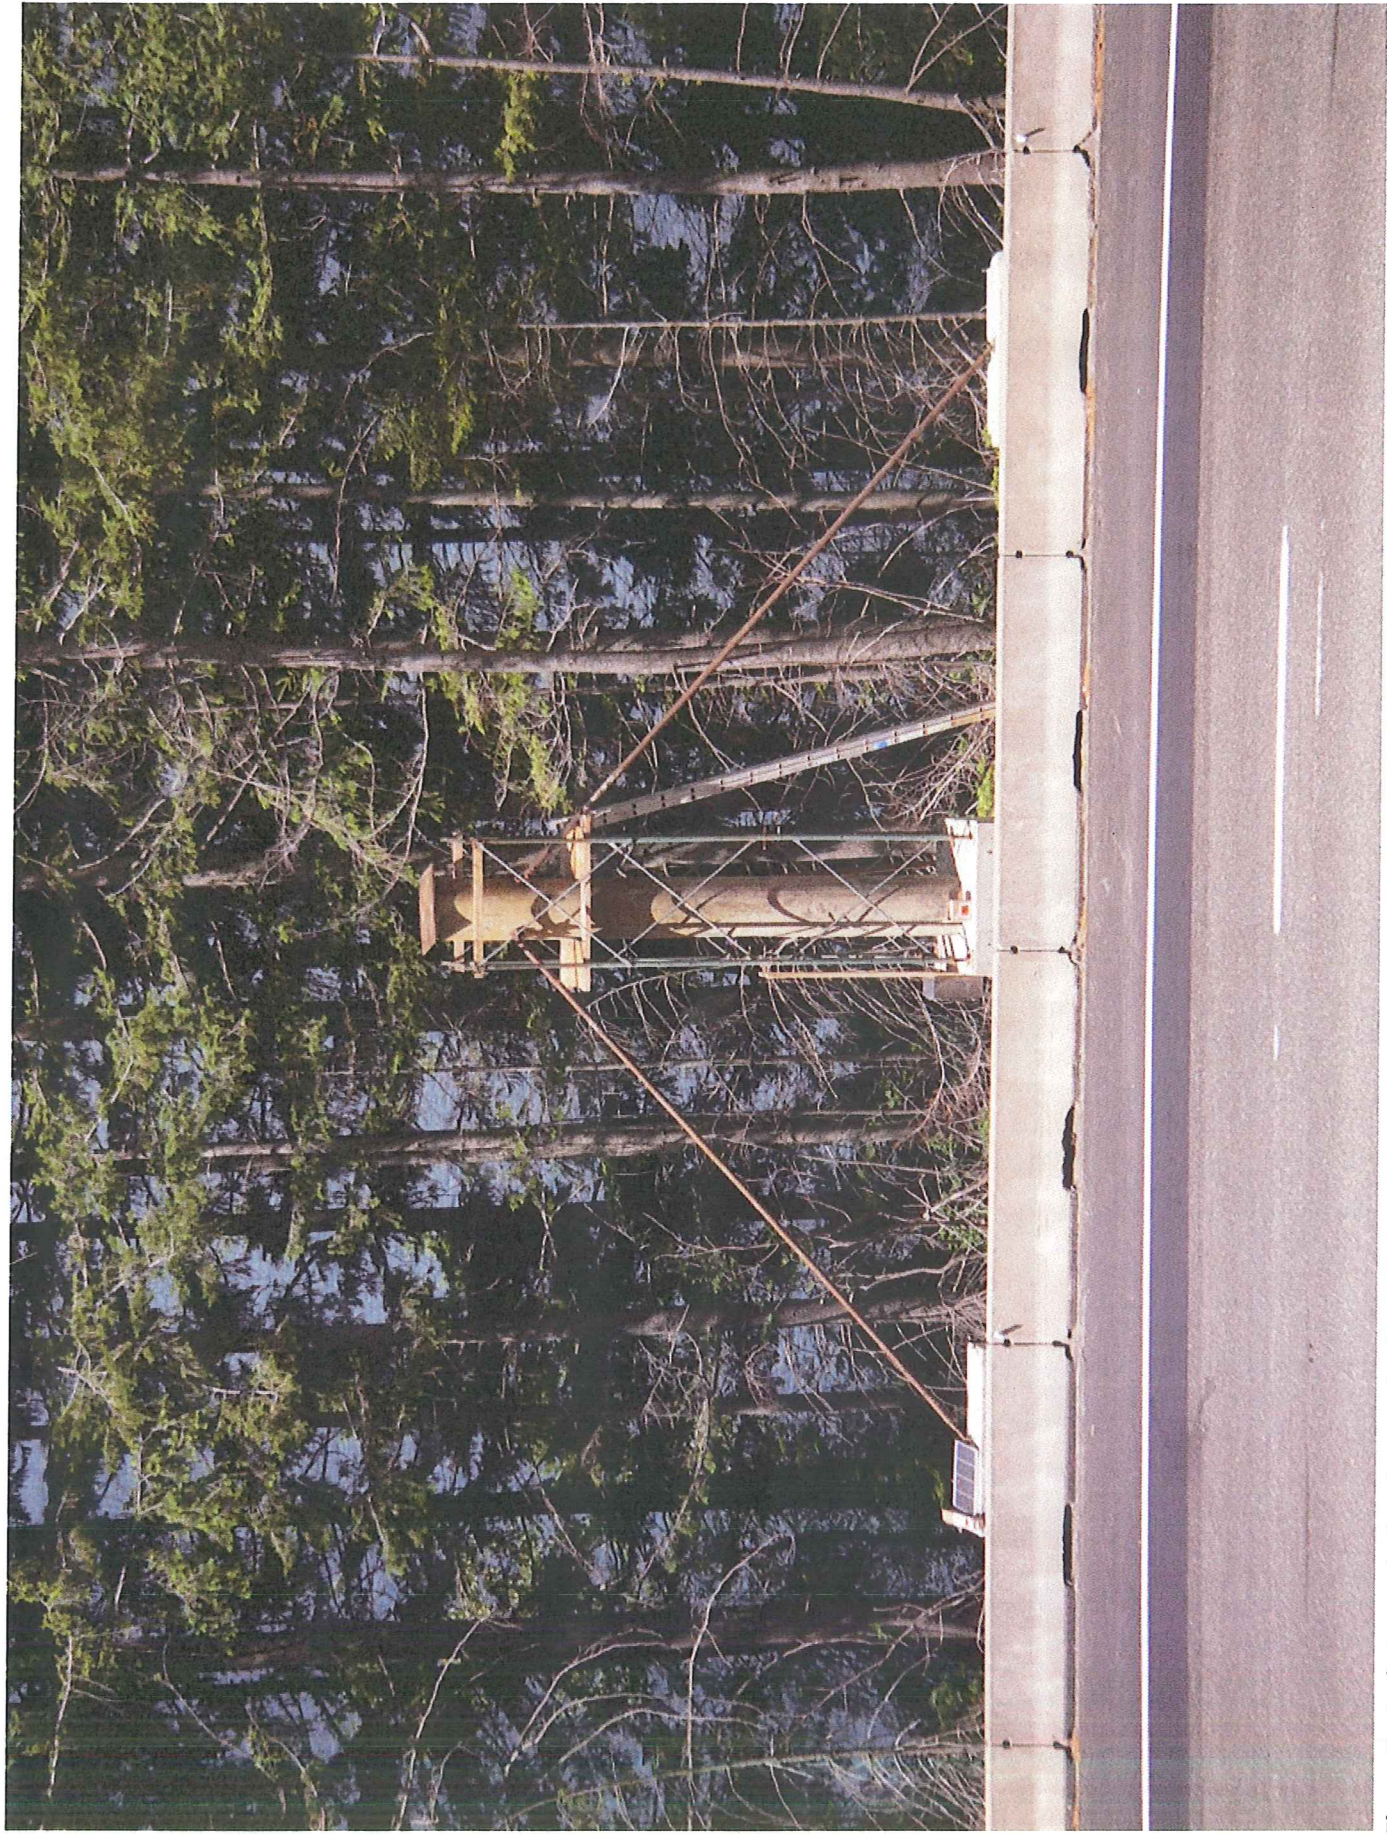
While I was on-site, Brad indicated that monitoring tower #3 was installed the previous night and is located at approximate station LW 1319+60 (Figure 3). According to Brad, the equipment was not in service at that time.

Figure 3. A photograph showing monitoring tower #3 located at approximate station LW 1319+60.

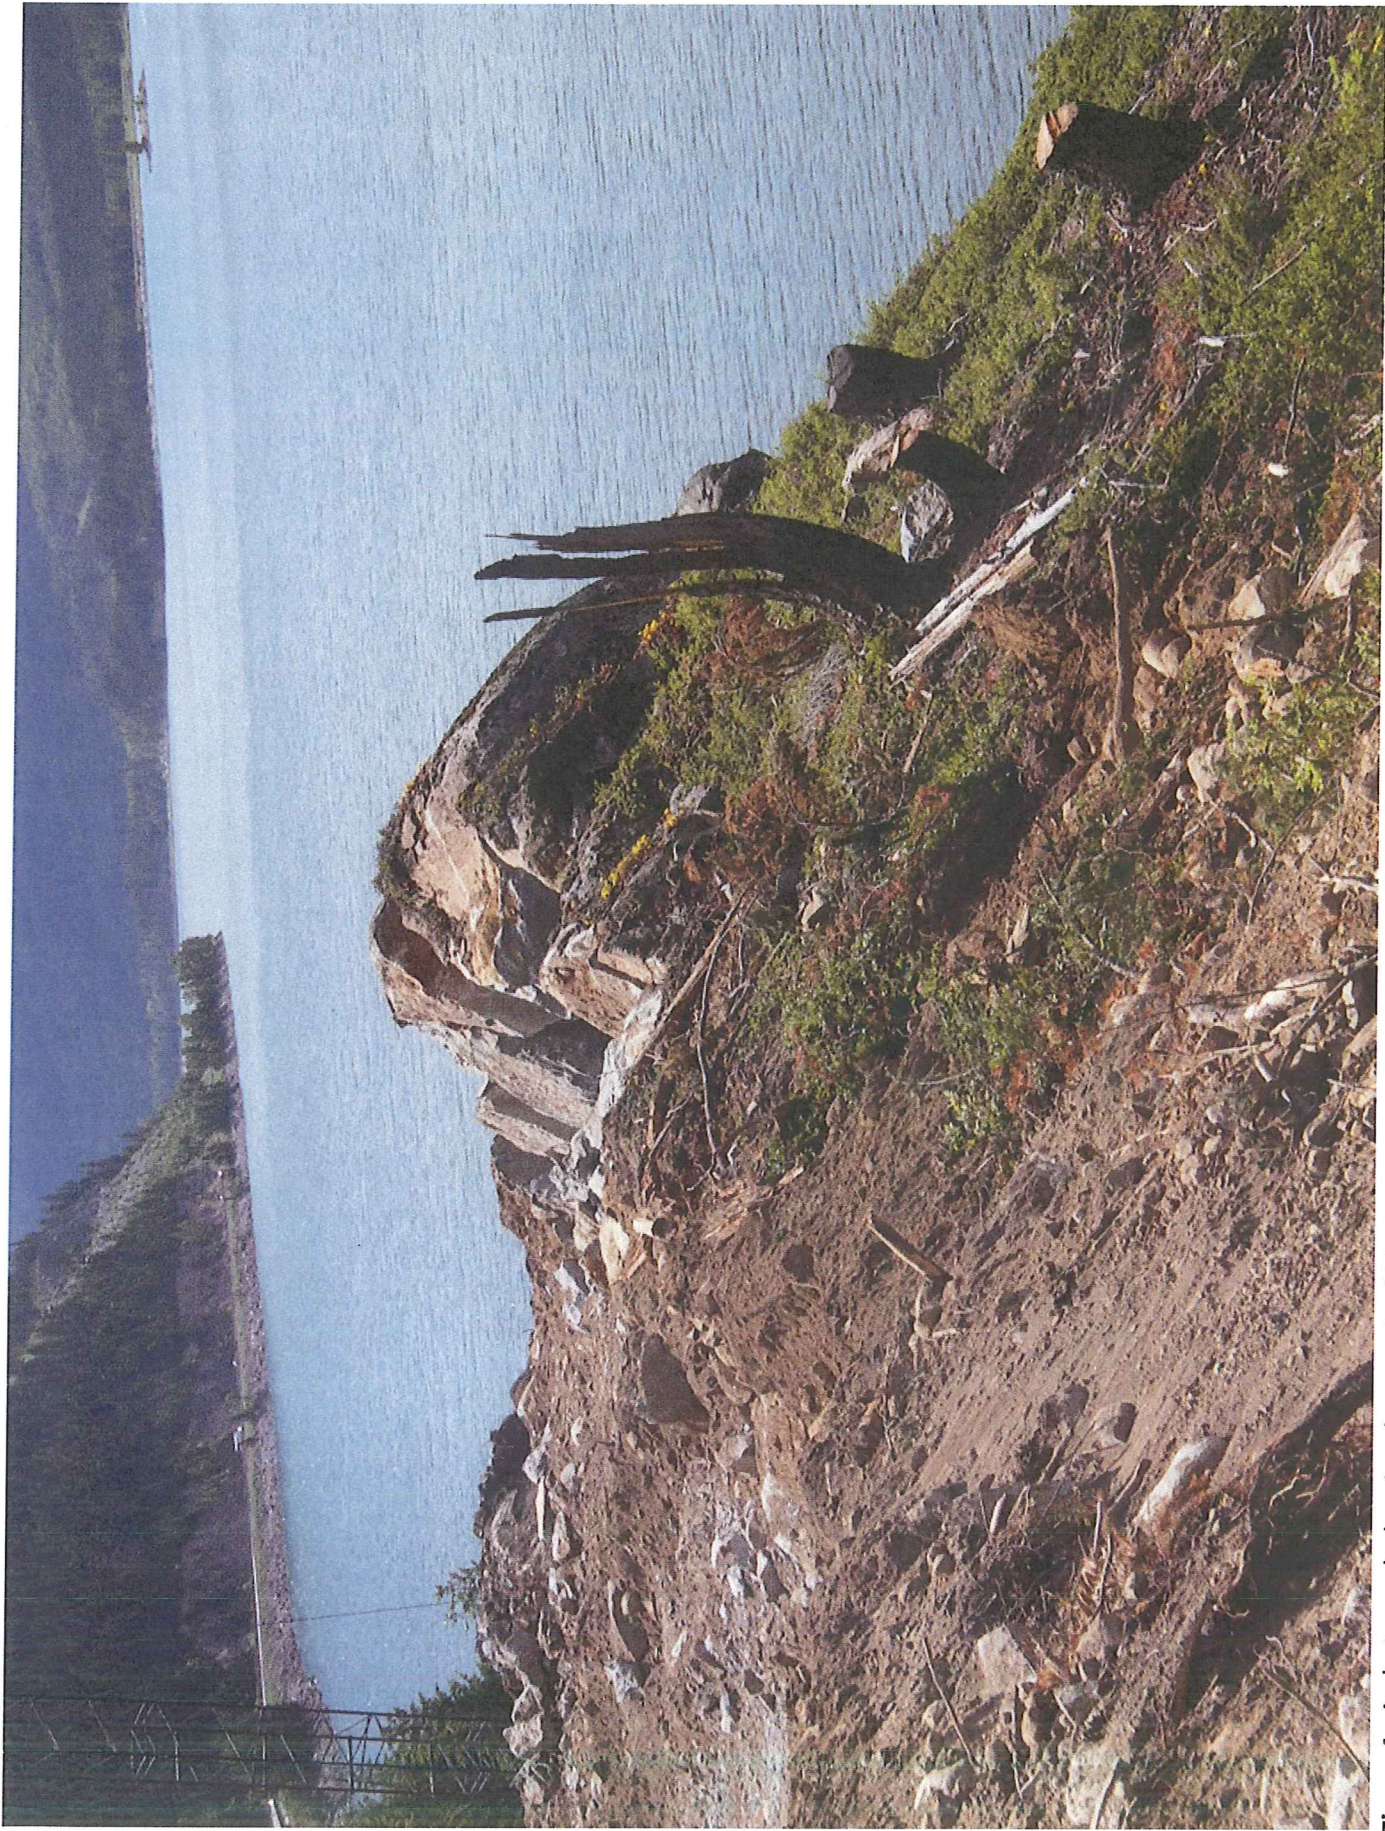
I checked in with Jerry Wood and he indicated that he would like someone from the Geotechnical Division to be present during the highway closure that evening to inspect the excavation that was going to take place around station LW 1337+00 of the oversized blocks that remained at the edge of the first production blast (Figure 4). I stated that I would be available for the requested inspection. Due to safety concerns and the size of equipment on site, the contractor indicated that they would like to blast the oversized blocks (to reduce them in size) rather than attempt to remove them in their current condition. WSDOT agreed and requested that the contractor provide a blast plan submittal for the intended work. The contractor indicated that they planned on blasting the oversized blocks the following evening (7/14).

Figure 4. A photograph showing the oversized blocks that remain on the slope at Lift 1 (approximate station LW 1336+50 to 1337+20).
